Experimental study of the brittle–ductile transition in hot cutting of SG iron specimens

Laurence Fouilland ^{a,*}, Mohamed El Mansori ^{a,b}

The present paper investigates the brittle-ductile transition (BDT) of the primary shear zone during cutting of spheroidal graphite (SG) iron in the austenitization temperature range (around 1000 °C). The experimental tests were performed using a cutting test bench in the cutting speed range of 0.8 to 1.6m.s⁻¹. The cut surfaces were studied using optical microscopy and Scanning Electron Microscope (SEM) analysis techniques. The obtained results revealed either consequent deep fractured regions governed by a brittle-cracking regime (BCR) or a crack-free cut surface governed by a ductile-shear regime (DSR) with large plastic deformations.

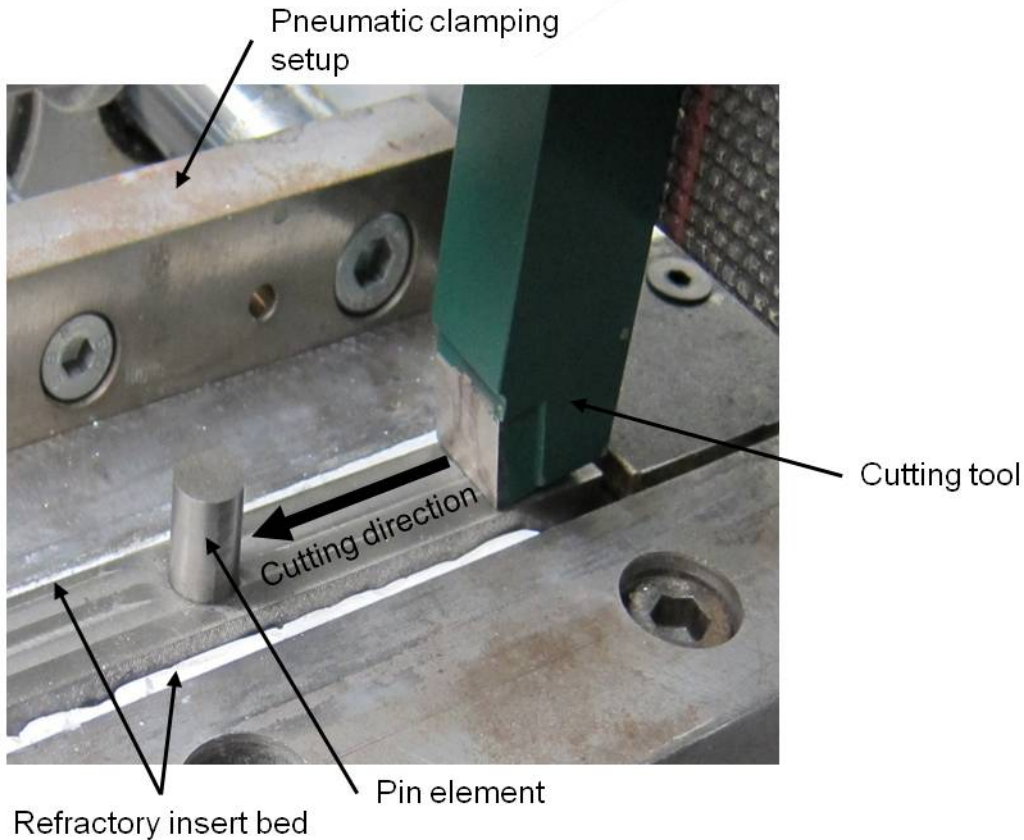
Figure 2. Hot cutting test arrangement:

The SG iron specimens consist in machined cast blocks with a pin element of a diameter ϕ and a height h which is entitled to reproduce a partly feeder neck (figure 2a).

The dimension h is of the same order of magnitude as a typical depth of cut while the dimension ϕ is made correspond to a representative shear plane length. The specimens are austenitized at 1000°C for ten minutes before the hot cutting process. The clamped specimen into a planning machine and the tool is shown in Fig. 2b. The clamping setup has been manufactured such as two pneumatic cylinders allow a rapid clamping of the specimen, and a bed of refractory inserts

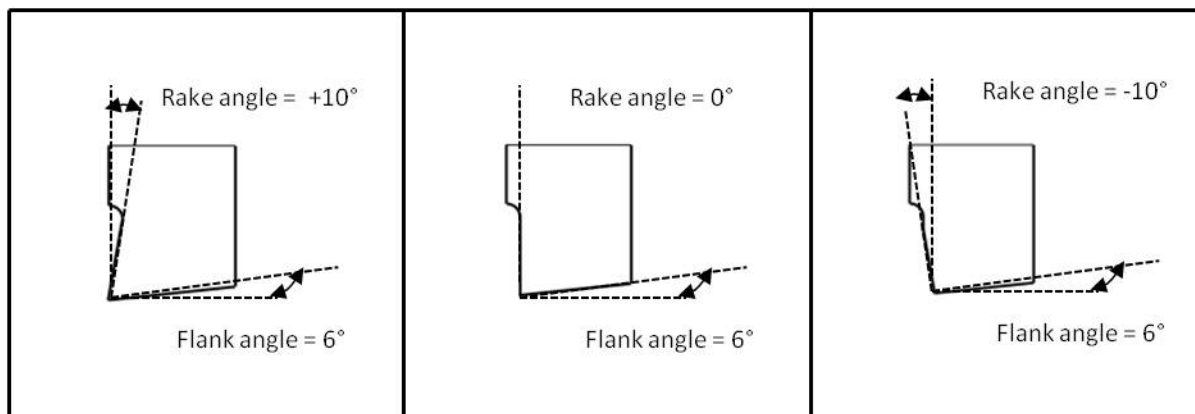
Table 2. Cutting tools geometry.

The orthogonal cutting tests has been performed at three different cutting speeds (0.8m.s^{-1} , 1.3m.s^{-1} and 1.6 m.s^{-1}) with three various rake angles ($+10^\circ$; 0° and -10°) using high speed steel (HSS) tools (flank angle = 6°). The cutting tools geometry is detailed in Table 2. The choice of such experimental variables has been guided by the processing conditions of SG iron rods and limited by the test bench capabilities. Moreover, three various heights h of the pin element (5 mm, 10 mm and 15 mm) and three diameters ϕ (5 mm, 7.5mm and 10mm) have been tested.

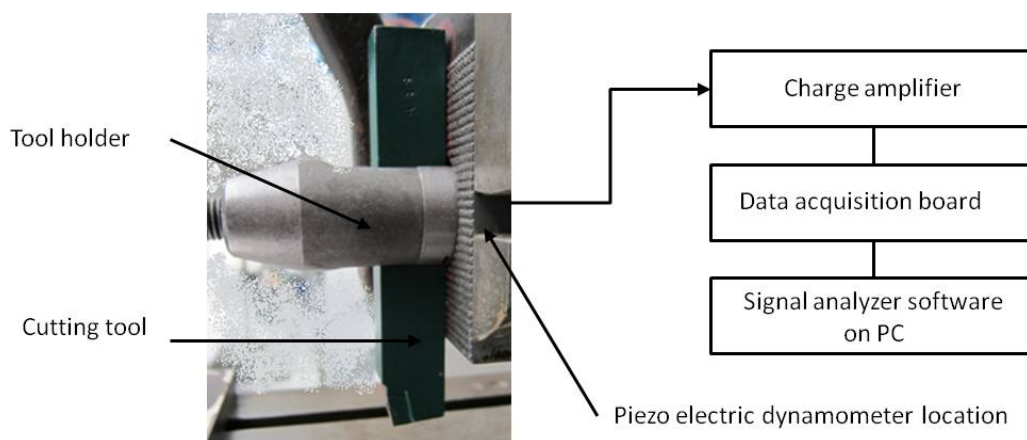
The cutting force in the cutting direction has been measured using a KISTLER piezoelectric dynamometer (type 9104A) mounted on the tool holder (Fig. 4). By the piezoelectric technology, when subjected to a cutting load, quartz produces an electrical charge proportional to the load.

Figure 4. Description of the force sensor setup
